El Paso County ROAD SAFETY AUDITS

February 2022

EL PASO   COUNTY
COLORADO

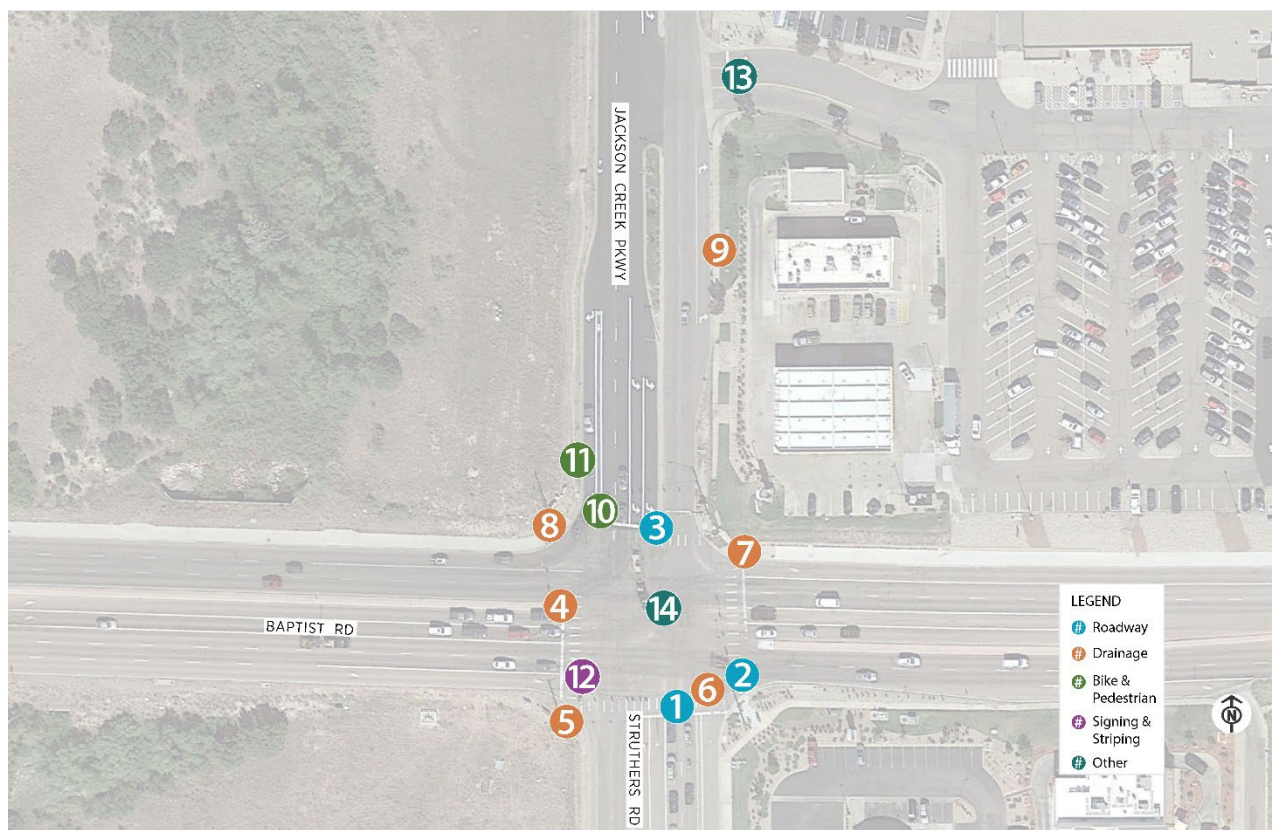
Figure 3 - Baptist Road / Jackson Creek Pkwy / Struthers Road Safety Issues Map

- Heavy traffic was observed in the morning and afternoon peak commuter periods. It was observed that during sunrise and sunset times of day, the signal heads were difficult to view along Baptist Road. This condition makes it challenging to see what signal phase (green, yellow, or red) was occurring when approaching the intersection.

- The King Sooper's driveway north of the intersection on Jackson Creek Pkwy has sight distance issues with traffic exiting the development to the west. This sight distance issue was observed and is related to obstructions to the north due to the height of the center median vegetation.
- Bicycle conflicts with vehicular traffic were observed, seemingly due to the termination of the Jackson Creek multiuse shoulder north of the intersection.

Speeding was observed along Baptist Road, potentially due to the intersection being located at the sag of two hills.

Debris such as gravel and sand were observed in the left-turn and right-turn vehicle paths. This could be an indication of potential drainage issues. The intersection is located at a low point, so debris and silt/sand likely flow to the intersection from the adjacent roads and developments.

- Traffic observations could not determine the reasons for broadside crashes. Signal timings did serve observed traffic appropriately, including yellow and red times. Broadside crashes could be associated with signal head viewing angles during sunrise and sunset times-of-day, windy conditions causing spanwire sway, or not obeying traffic signs, signals, or laws.

- Location 14: Signal heads without backplates can impact signal head visibility.
- Location 1: Pavement failure at the stop bar on the south leg. Pavement irregularities can impact cyclist path/ride and can be a tripping hazard for pedestrians.

- Location 2: Scuff marks and curb damage on the southeast corner. No field observations identified issues for passenger cars; however, most likely due to larger vehicles making U-turns. Marks represent vehicles not staying within the travelway.

- Location 3: Sign within the median is missing due to vehicles hitting it and median curb is damaged on the north leg. The signage damage indicates fixed object type crash, these types of crashes are not always reported but can produce unsafe driving conditions. Verify that the median is at least 4-feet wide for vehicle clearance needs.

- Location 11: Sidewalk is missing for approximately 745' on the southbound side of Jackson Creek Pkwy. The worn path demonstrates a need for a sidewalk.

- **High Priority** – Review the striping plan and maintenance schedule for the Baptist Road/ Jackson Creek Pkwy/ Struthers Road intersection. Location 12: In high-volume areas or where road sand may rub the paint off quickly. If paint is wearing prematurely, consider an alternative product or process. Reflective striping reduces nighttime crashes and sideswipe (same direction) crashes. (\$/\$\$\$)
- **High Priority** – Review and change the signal timings based on flow conditions. Updating signal timings can reduce rear-end, same direction sideswipe, broadside, and approach turn crashes. (\$)

- **Low Priority** – Consider Dynamic Speed Feedback signs along Baptist Road. These types of signs are recommended to reduce speeding. Speeding can cause rear-end crashes when vehicles do not have sufficient time to stop at the intersection. **(\$)**

- **Low Priority** – Location 1: Ensure the intersection is on a regular paving schedule, monitor quality of roadway and, when conditions worsen then a maintenance solution should be provided. **(\$-\$\$\$)**

- **Low Priority** – Location 4-6, 8: Coordinate with Monument to evaluate drainage at the intersection; consider street cleaning maintenance at the intersection **(\$/\$\$\$)** Cost depends on drainage issue and level of effort is needed to repair.

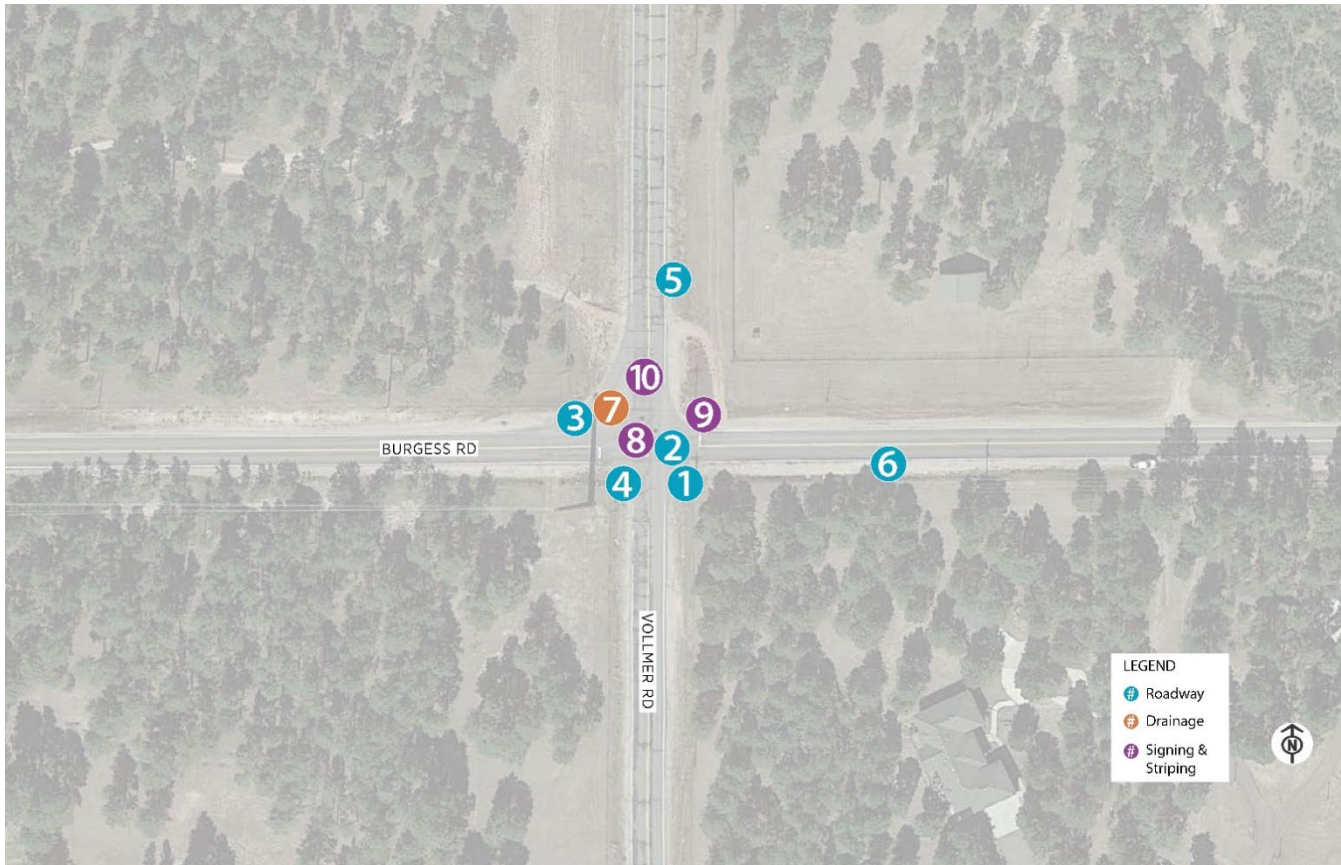
Figure 5 - Burgess Road / Vollmer Road Safety Issues Map

- Heavy traffic was observed in the morning and afternoon. Burgess Road drivers had difficulty finding gaps crossing Vollmer Road and accepted smaller gaps to cross. There were observed near misses due to this.
- Backups along Burgess Road, especially eastbound was observed during both morning and evening commuter peak periods. At multiple times, over 20 vehicles were observed to be queued.
- During the morning commuter peak period during sunrise, eastbound visibility is severely compromised and makes it difficult to navigate the roadway and the intersection.
- It was also observed that heavy traffic was present outside of peak commuter periods.
- The corners of the intersection had rutting, which indicates the paved portions of turning radiuses are not sufficient.

- Location 1: Deterioration of pavement, soft shoulder and potential vehicle or trailer pathing are apparent in the southwest intersection corner/shoulder. Soft shoulders with significant drop off from the pavement can cause vehicles to lose control, have a difficult time correcting loss of control, and can cause overturning crashes or be a contributing factor to other types of crashes.

- Location 2: Worn pavement observed at the intersection can impact cyclists' control to safely traverse intersection.
- Location 3: Transverse crack in pavement on the west leg can lead to further pavement damage if not repaired.

- Location 4: Deterioration of pavement, soft shoulder and potential vehicle or trailer pathing are apparent. Soft shoulders with significant drop off from the pavement can cause vehicles to lose control, have a difficult time correcting loss of control, can cause overturning crashes or be a contributing factor to other types of crashes.

- Location 5: Steep shoulder is a concern because vehicles can have a difficult time correcting if veering off the shoulder. This is a very dark area, and the roadway edge is difficult to see during nighttime conditions.

- Location 6: Soft shoulders with significant drop off from the pavement can cause vehicles to lose control, have a difficult time correcting loss of control, and can cause overturning crashes and be accompanying causes to other types of crashes.

- Location 10: Worn striping on the north leg of the intersection can impact vehicle channelization.
