El Paso County ROAD SAFETY AUDITS

February 2022

EL PASO   COUNTY
COLORADO

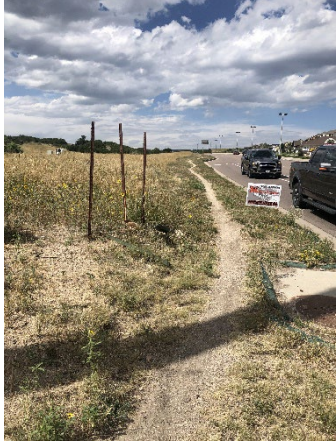
11

- Location 11: Sidewalk is missing for approximately 745' on the southbound side of Jackson Creek Pkwy. The worn path demonstrates a need for a sidewalk.
